FINAL REPORT
ON THE
ESTABLISHMENT OF ENGINEERING DESIGN DATA FOR
HYBRID STEEL/CERAMIC BALL BEARINGS

N00019-78-C-0304

SEPTEMBER 28, 1979

PREPARED BY: SKF TECHNOLOGY SERVICES
1100 FIRST AVENUE
KING OF PRUSSIA, PA. 19406

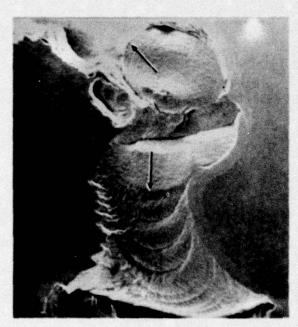
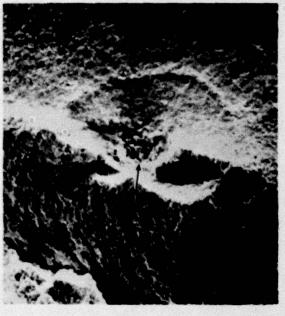
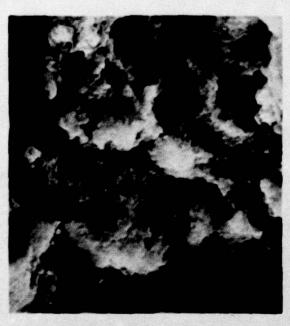
FIGURE 11

The spalled ball from bearing 104 which lived only slightly longer than 108, is shown in the photomicrographs of Figure 11. This failure appears to have initiated at a small void in the material. Since voids would normally be formed by the presence of a foreign substance in the powder which reacts with the silicon nitride at the pressing temperature, it would be expected that the microstructure in the area of the void would be atypical. As can be seen from photomicrograph 7780, this is indeed the case as the grains do not have the well defined edges and hexagonal shape seen in normal hot pressed silicon nitride.

Void Type Spall Origin Found in Silicon Nitride Ball From Bearing 104

7776 40X Arrows Depict Crack Propagation Direction

7777
Arrow Points to Suspected
Fracture Origin

7780 5000X Microstructure at Fracture Origin

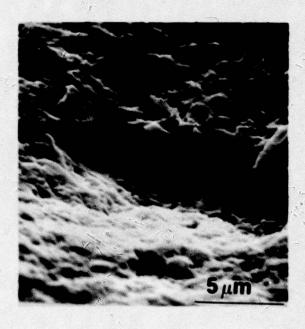
FIGURE 16
Higher Magnification View of Spall Origin in Ball From Bearing 130

7816 5000X Orientation Same as Shown in Photo Number 7815

7819 5000X 180° Rotation From Photo Number 7816

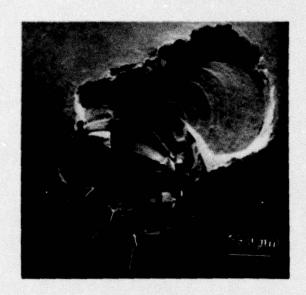
FIGURE 19

A spalled ball from bearing 126 which lived only slightly longer than 130, is shown in Figure 19. Some unusual particles were discovered at the failure origin as shown in photomicrograph 7805. Elemental analysis established that the particles were rich in carbon. This coupled with the particle morphology implied that the contaminant was graphite. Graphite is used as die material for the silicon nitride hot pressing operation so it is easy to envision that this contaminant could be introduced into the silicon nitride powder. Figure 20 shows a fracture surface of the specific graphite compound used in the mold. As can be seen, the morphology of the particle identified with the arrow is very similar to that seen on the foreign particles found in the ball material. Thus it would seem conclusive that the contaminant was graphite from the pressing mold.

Inclusion Type Spall Origin Found in Silicon Nitride Ball From Bearing 126

7802 50X Spall Origin Indicated by Arrow

7805 1000X Unusual Particles Noted At Spall Origin

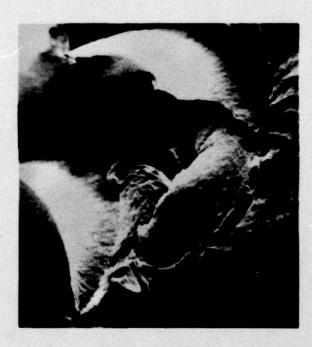
FIGURE 21
Spall Found in Silicon Nitride Ball From Bearing 127

Figure 21 shows the spalled ball from bearing 127, one of the two longest lived failures in the low load test group. As was the case with the long lived failure from the high load test group, a specific failure origin could not be identified. Again the failure initiator could have been destroyed by the spalling process or this could be a valid fatigue spall.

7821 25X 7822 50X

7823 100X 90° Clockwise Rotation
